Offset Deformable Barrier – Frontal Impact

Bumper Beams and Front Chassis Leg

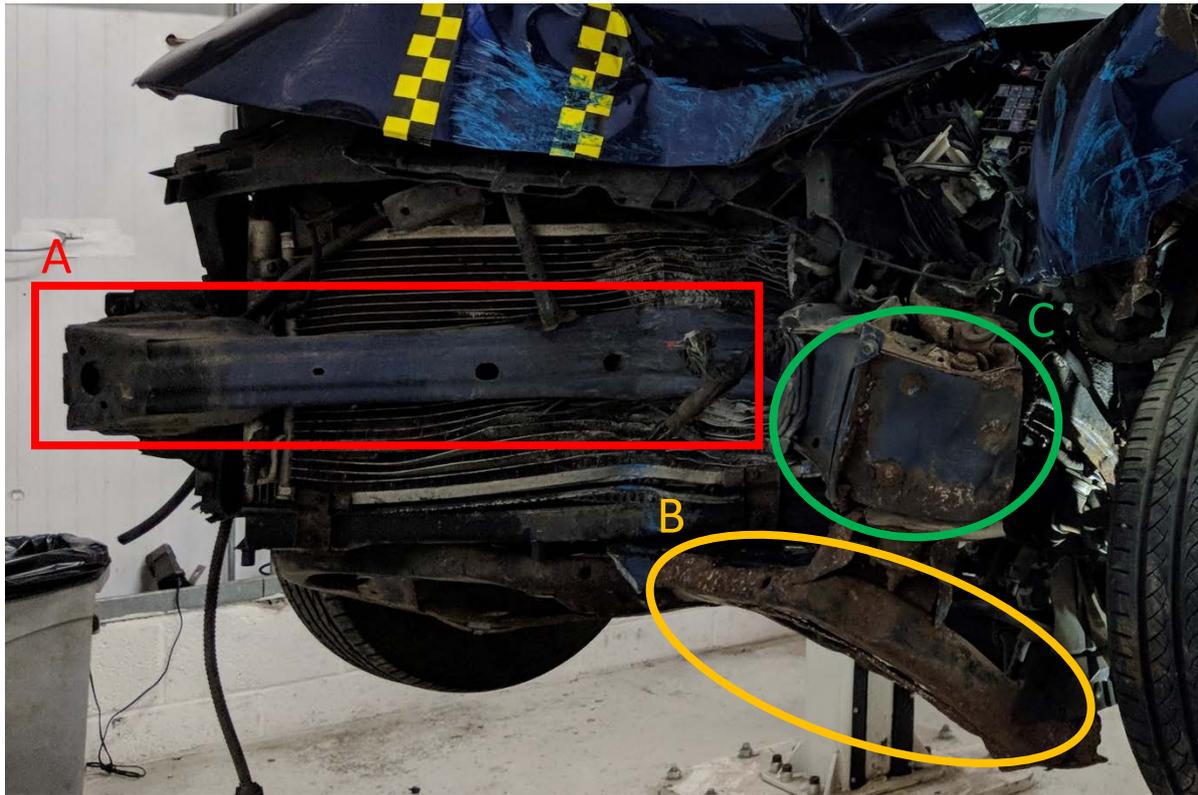
Figure 1 ODB front upper bumper beam(A), front lower bumper beam(B) and the chassis leg(C).

Figure 1 shows the front bumper beam mounted to the chassis leg, with the separate lower bumper beam below it. Figure 2 and 3 highlight the large amount of the on the chassis leg, both on joins and through the top face of the chassis leg.

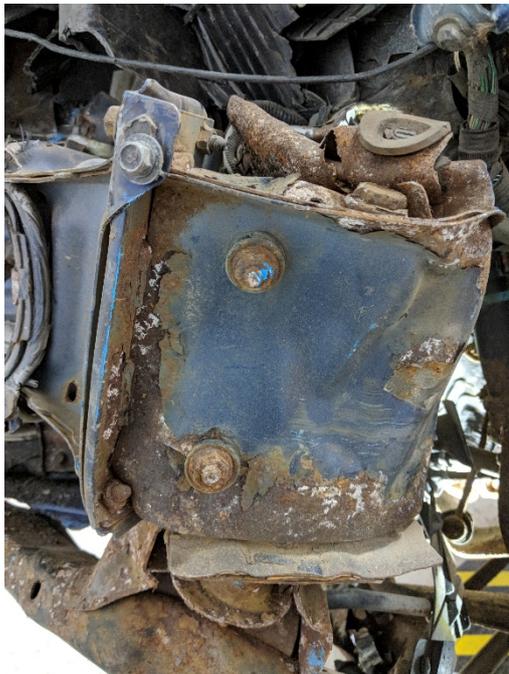
Figure 3 Front Chassis Leg Side View

From Figure 2 and 3 the extent of the rust is very severe; however, it does not appear to have greatly affected the structure of the lower chassis leg. The welds on the left image have not failed despite being surrounded in rust. The top of the chassis leg can be seen from the Figure 4, and once again the rusted areas do not appear to have cause any structural weakness in the material. This level of deformation of the front chassis leg is to be expected from the ODB impact, but without any original 2003 test images it is impossible to say with certainty if this vehicle reacted differently.

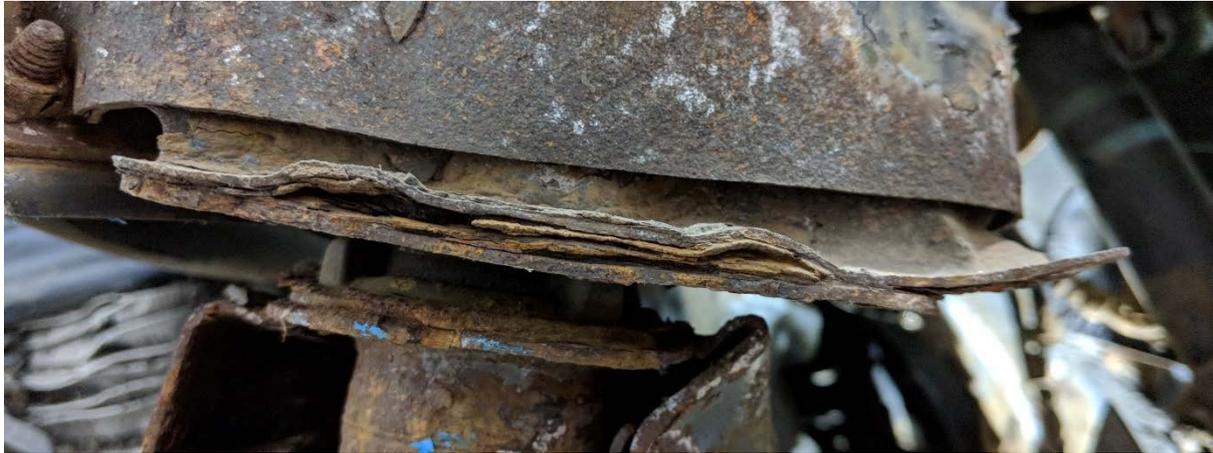
Figure 4 Front Chassis Leg Bottom View

Figure 4 again highlights the extent of the rust, with the thinner parts of the material starting to flake away from the main material. Although this particular part of the chassis leg is not crucial to the crash performance, it does indicate the level of corrosion present in the vehicle.

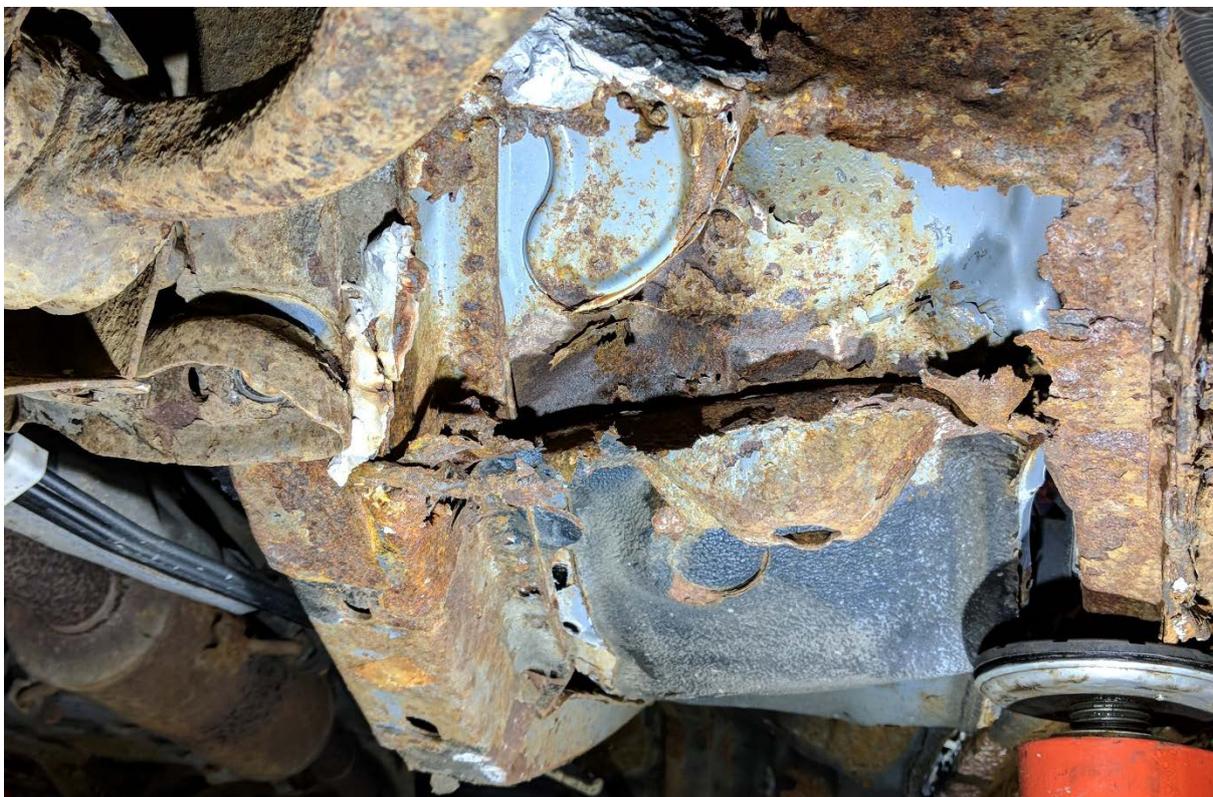
Figure 5 Lower Chassis Rail

Figure 5 shows where the front chassis leg joins the lower chassis rail. Once again, the extent of the rust is shown, not only on the chassis rail but on the sill as well. The floor underneath the driver compartment has deformed, collapsing downwards along the length of the chassis rail. This has also caused the chassis rail and floor to de-bond in multiple sections along the length of the vehicle (shown in Figure 6).

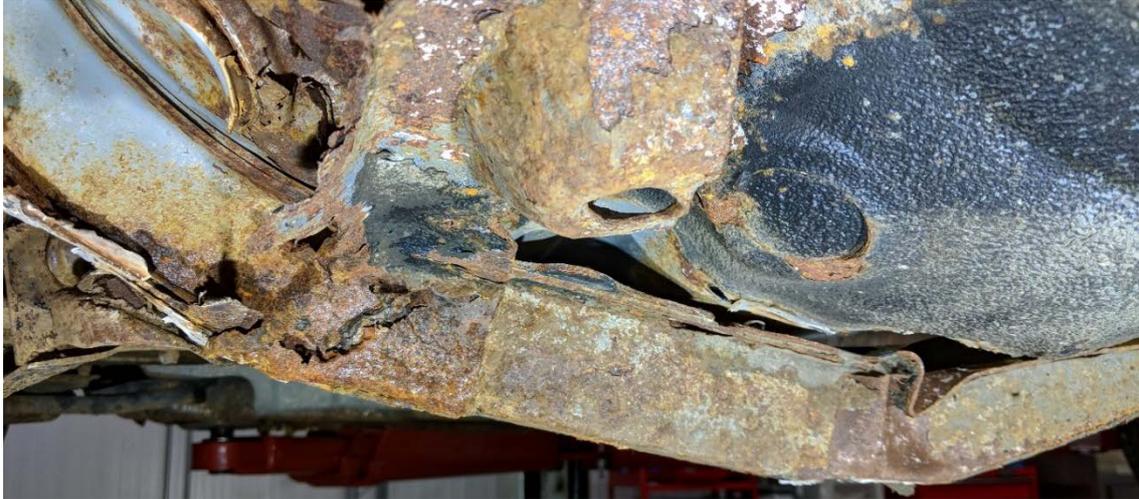
Figure 6 De-bonding of chassis rail and floor

The point at which the chassis leg meets the lower chassis rail is severely covered by rust, however this section did not fail as shown in Figure 6. The point of failure is the spot welds between the two sections. Once these spot welds failed, the floor section was able to greatly deform into the passenger compartment. It was noted in the original 2003 Euro NCAP Test that the footwell of the vehicle ruptured, and without original test images it is difficult to say what the extent of this deformation was.

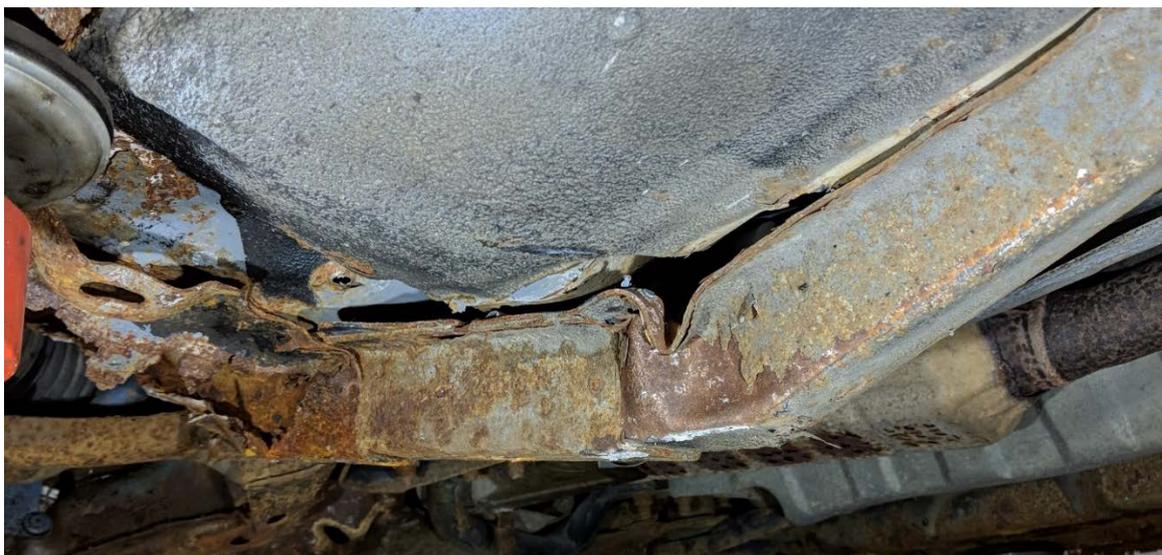
Figure 7 shows that further rearwards the chassis rail buckled, but there is no evidence that this is due to excess rust in that particular area. This buckling is also causing additional separation of the floor and chassis rail. This is evidence for the bodyshell integrity modifier, as any additional load in a higher impact would not be transmitted in a controlled manner.

Figure 7 Lower Chassis Rail Buckling

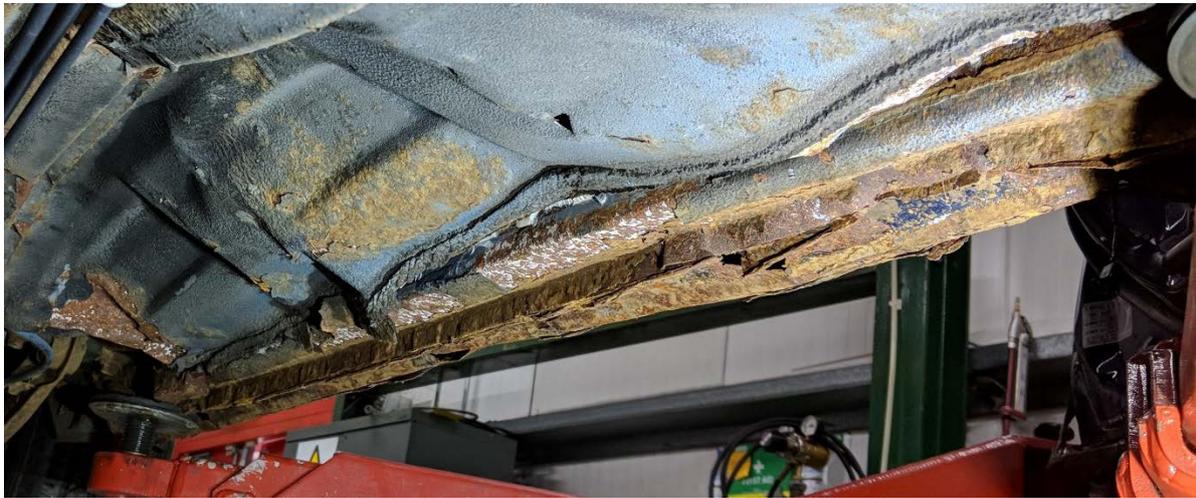
The sill on the underside of the vehicle was heavily covered in corrosion, seen in Figure 8. The rust extends down the entire length of the sill, with evidence of flaking and splitting between layers.

Figure 8 Extent of the corrosion on along the sill

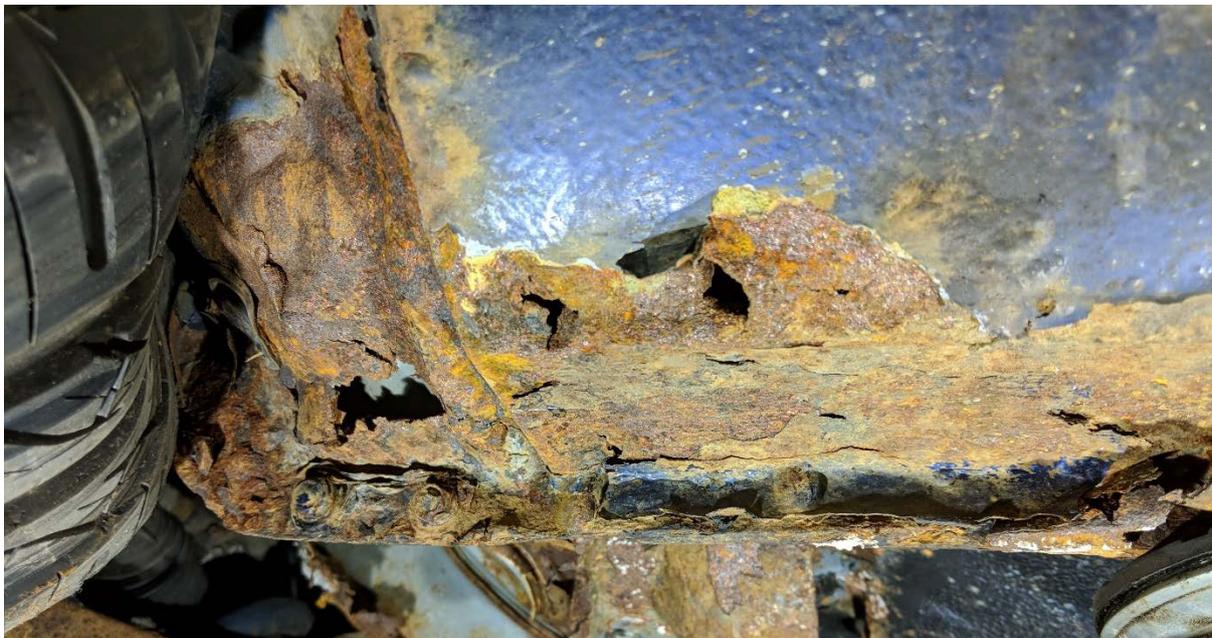
The sill is often used by manufacturers as a load path during the ODB impact. Figure 9 shows the area of the sill directly behind the driver side wheel. Once again the level of corrosion is evident, with holes in the metal clearly visible. This is one of the highest loading points of the ODB impact, and so any structural weakness should be visible here. From Figure 9, the sill structure has not entirely collapsed, despite the extensive rust and the high load put through it. The high-speed video suggests that the loads were completely transferred through this section, with no energy absorption taking place. This then caused the deformation further rearwards of the vehicle. It is difficult to determine whether this is part of the original crash structure of the vehicle.

Figure 9 Sill structure behind the driver side wheel

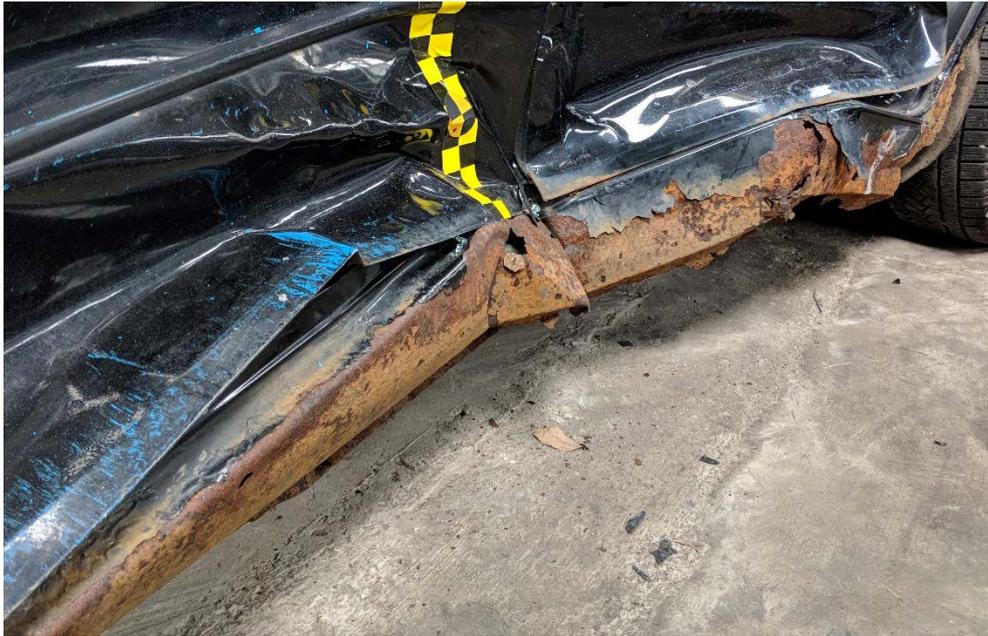
Figure 10 shows the deformation of the sill after the MDB impact. The footwell can be seen to have buckled a large amount in the impact, which most likely caused the additional compression of the ribs in the dummy. Again it is difficult to say whether the corrosion caused additional collapse of the sill and B-pillar without knowledge of the original 2003 impact.

Figure 10 MDB Sill Rust

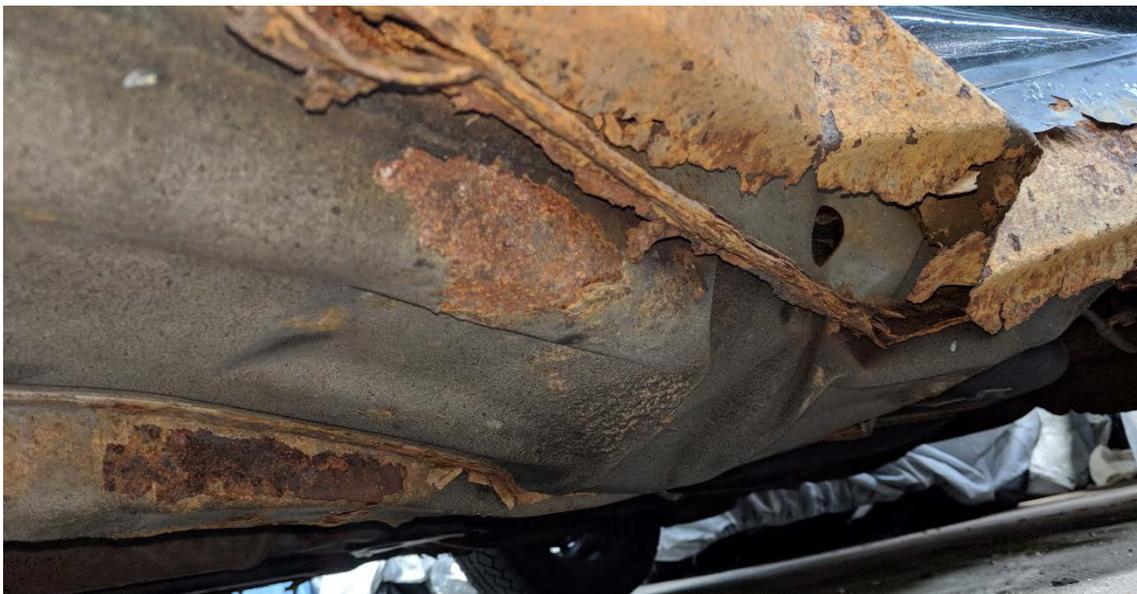
Figure 11 shows where the sill has not transferred the load in a controlled manner, causing the sill outer layer to spit, and then deform the floor of the passenger compartment. This in turn cause the driver seat mounting to move during the impact. This also most likely aided the higher loads seen on the dummy lower ribs.

Figure 11 Floor deformation and Sill outer layer
